FINAL REPORT
SRB SEAWATER CORROSION PROJECT
July, 1991
(NAS8-38800)

Auburn University, Solid State Sciences Center,
Department of Physics

M. J. Bozack

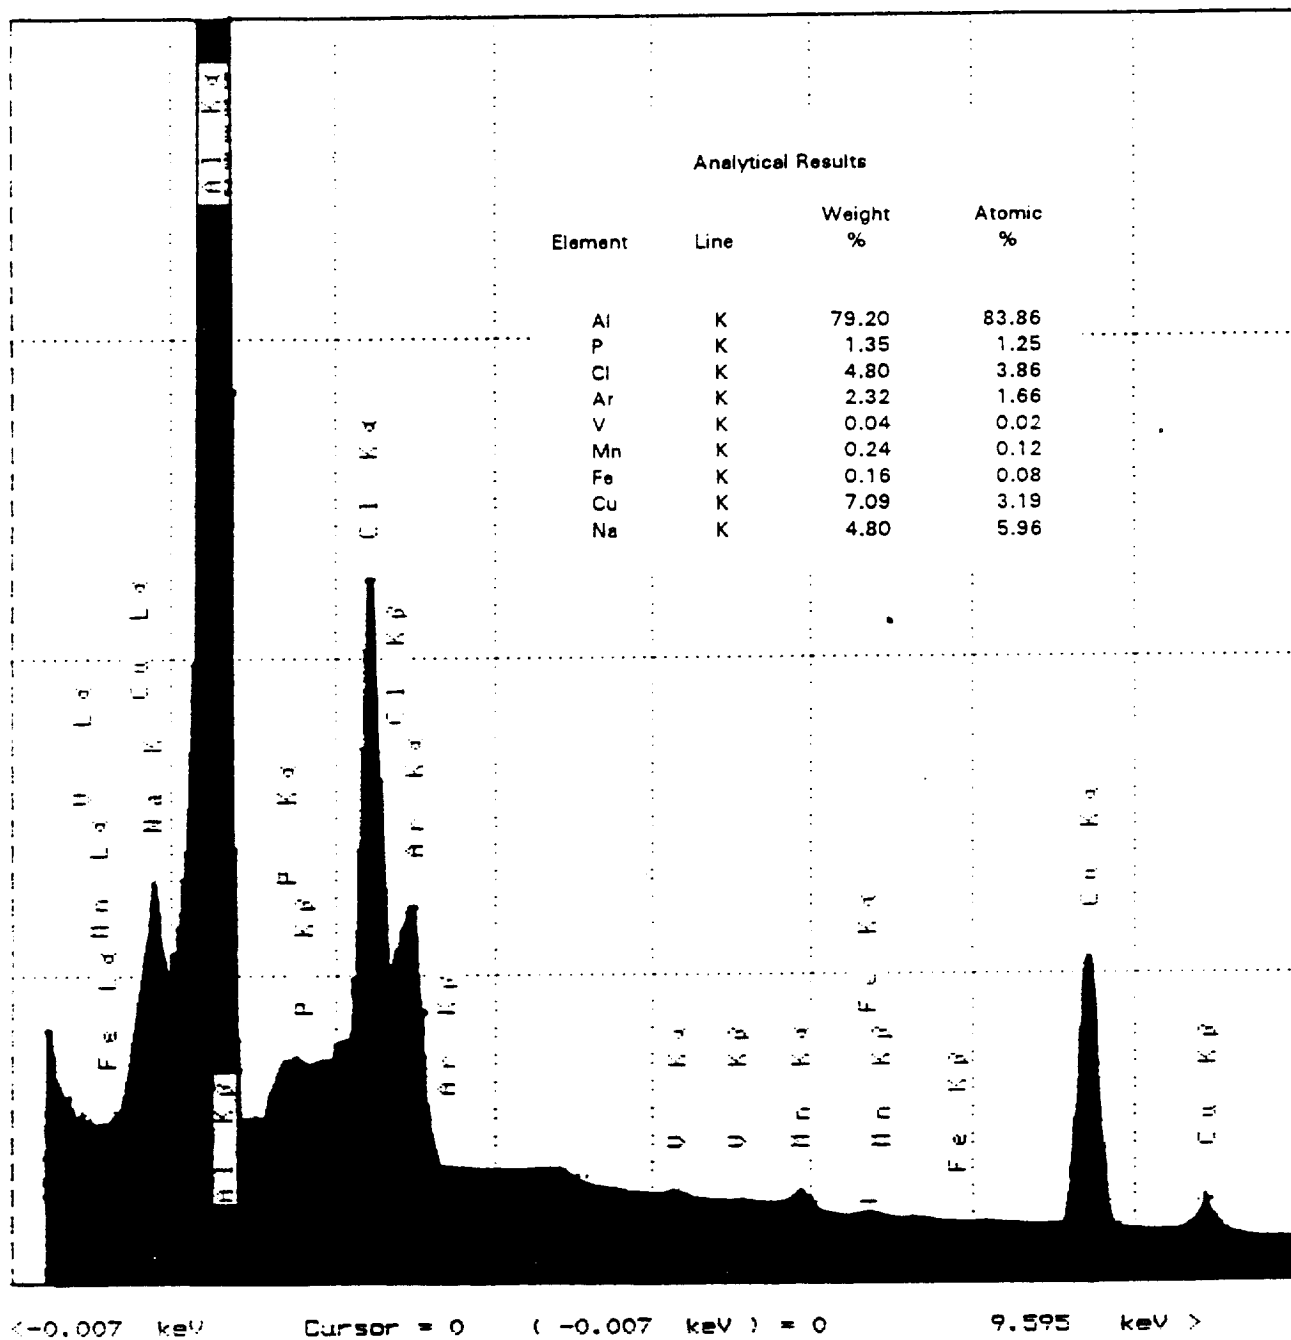
Fig. 32.

A high magnification SEM view of the exposed surface is shown in Figure 31. An EDX spectrum over the area-averaged view shown in Fig. 31 is displayed in Figure 32. The composition is roughly the same as for the $T = 30\text{ C}$ case, mostly Al, Na, and Cl. Auger analysis atop the hazy film is also shown in Figure 33. The Auger signature is that of Al_2O_3 , shown by the energies and shapes of the Al Auger peak. NaCl is also present on the surface because it was observed in EDX, but ESD effects make it difficult to observe. Accounting for this effect in Auger spectroscopy, and comparing

Area-averaged EDX spectrum over the view shown in Fig. 31. The spectrum is similar to the 2219 alloy itself, with the addition of a small amount of NaCl.

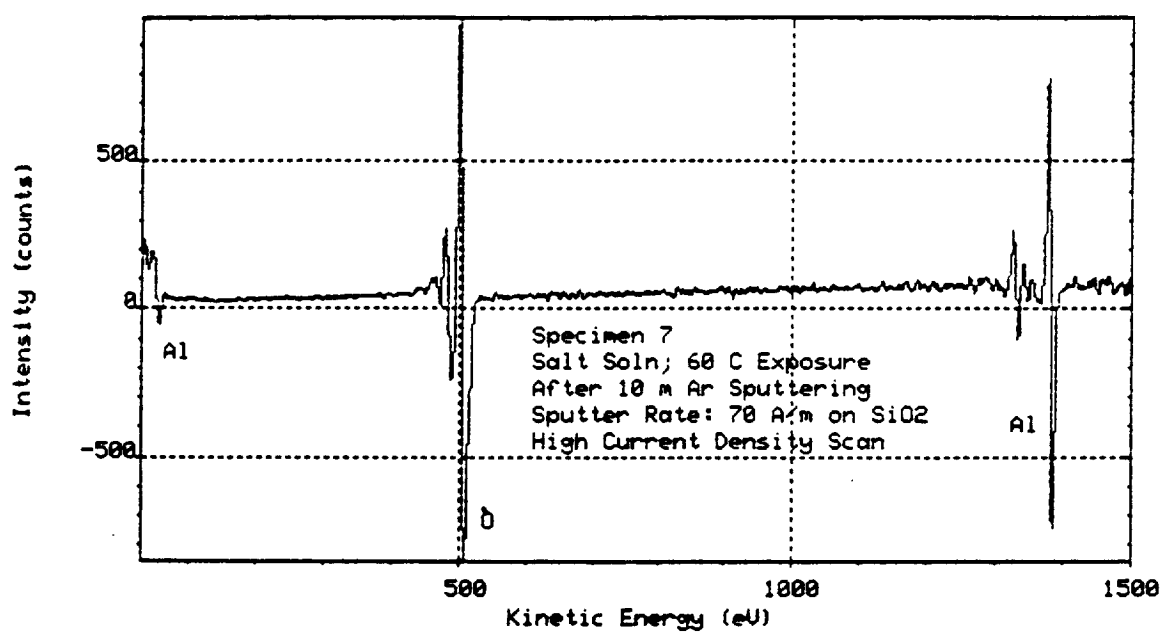
Fig. 33. Area-averaged Auger spectrum over the view shown in Fig. 31. Growth of Al_2O_3 and NaCl dominates, similar to the case at $T = 30$ C, despite the fact that NaCl is not observed in Auger spectroscopy.

spectra taken by EDX, shows that the predominant reaction mechanism at $T = 60\text{ C}$ is growth of Al_2O_3 and NaCl . This is similar to the reaction at $T = 30\text{ C}$.

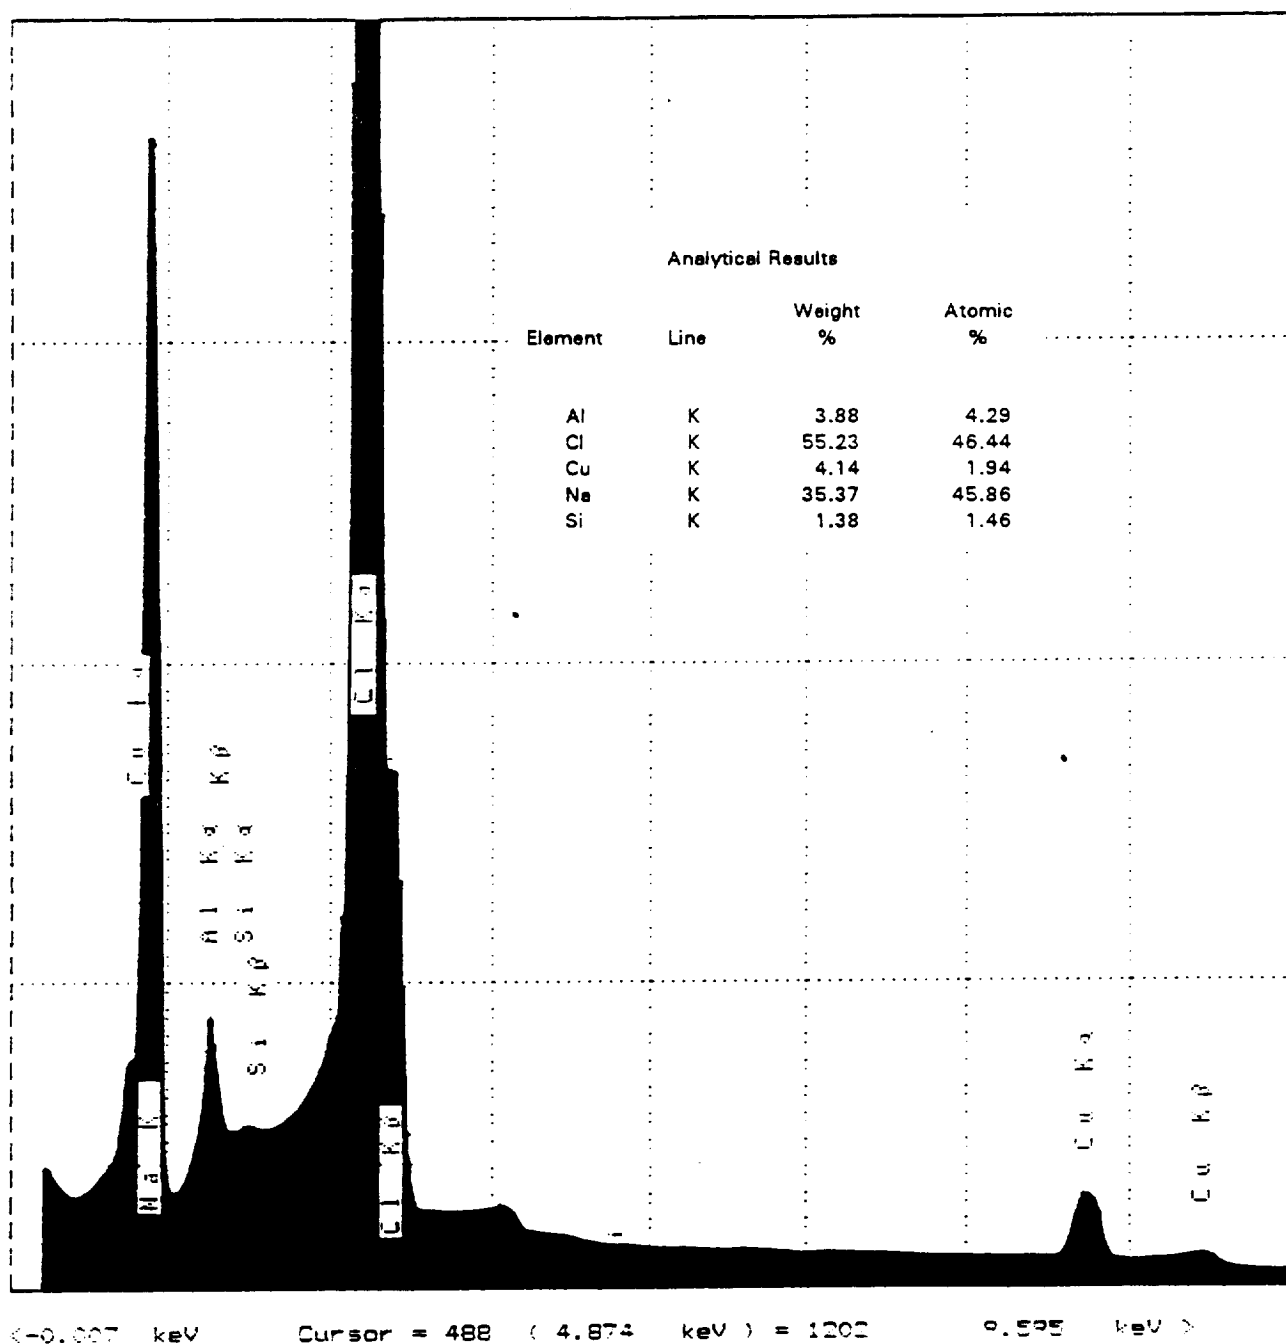
An EDX spectrum on and beside one of the crystals in Fig. 34(b) is shown in Figures 35 and 36, proving that the crystal are salt. While the crystals are salt, the material beside the crystals is predominantly Al, reflecting the substrate. Auger analysis (not shown) verified that the crystals were NaCl and the substrate was oxidized Al.

Fig. 35. EDX spectrum atop one of the crystals appearing on the $T = 100\text{ C}$ exposed surface (position 1 in Fig. 34(b)). The crystals are NaCl.

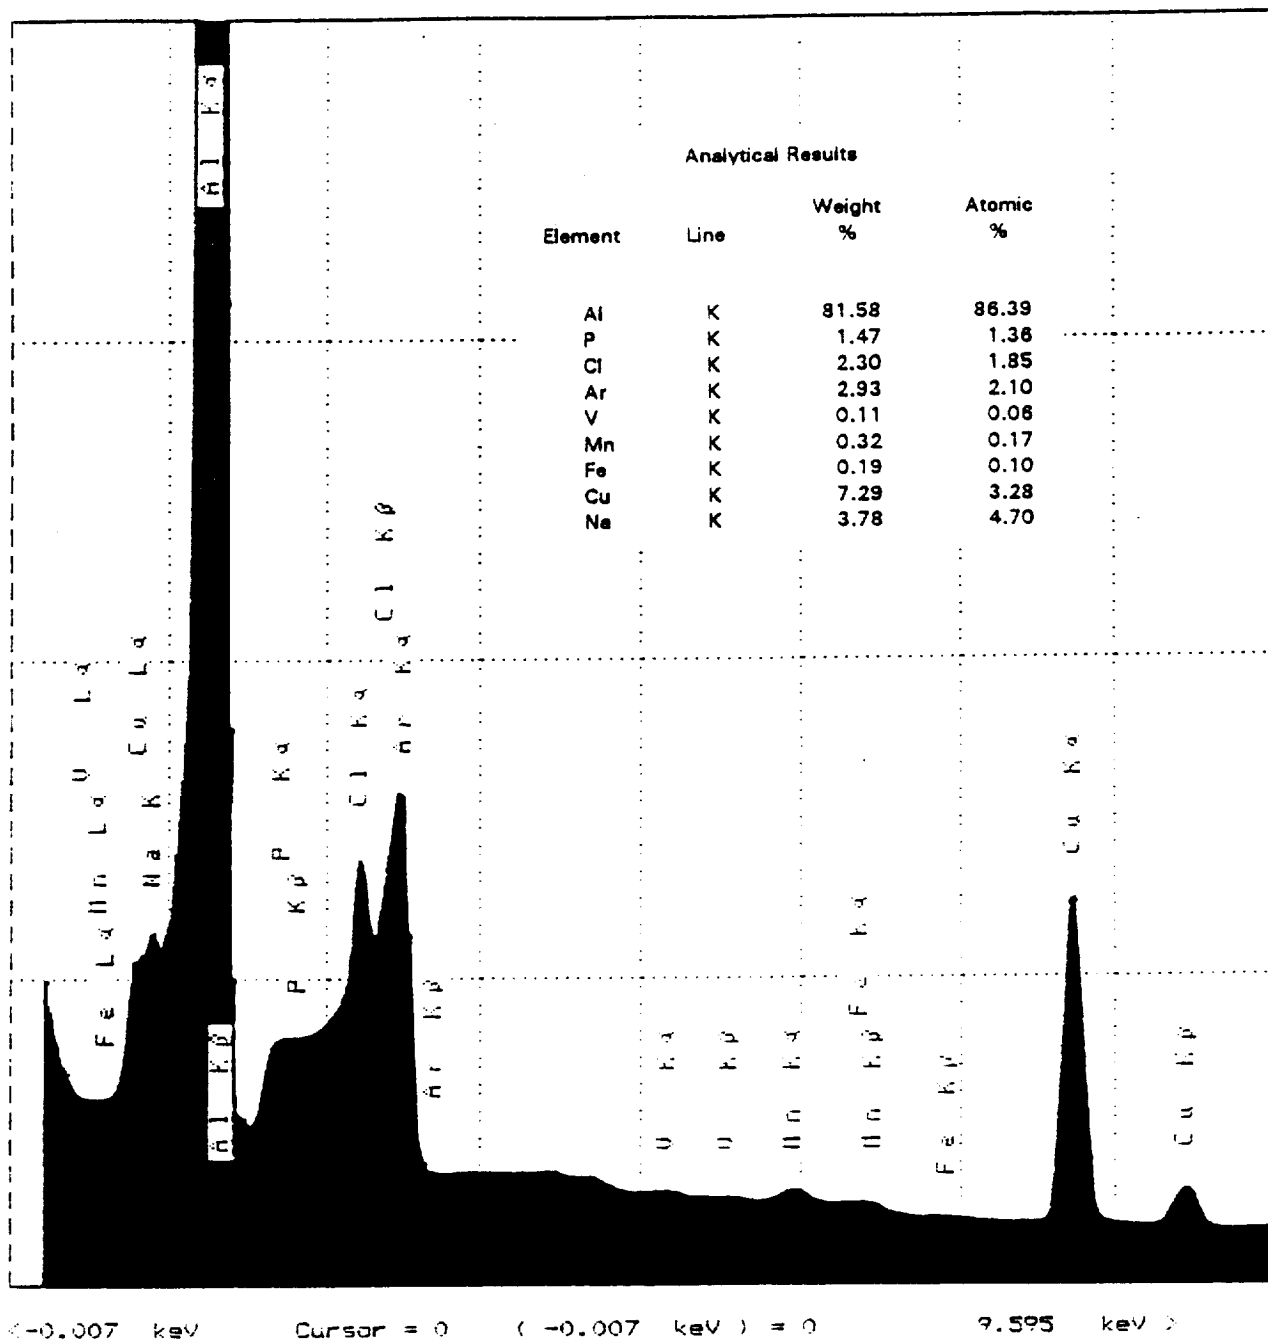
Fig. 36. EDX spectrum alongside one of the crystals seen in Fig 34(b). The spectrum is similar to that for the 2219 alloy itself, with the addition of small amounts of NaCl.

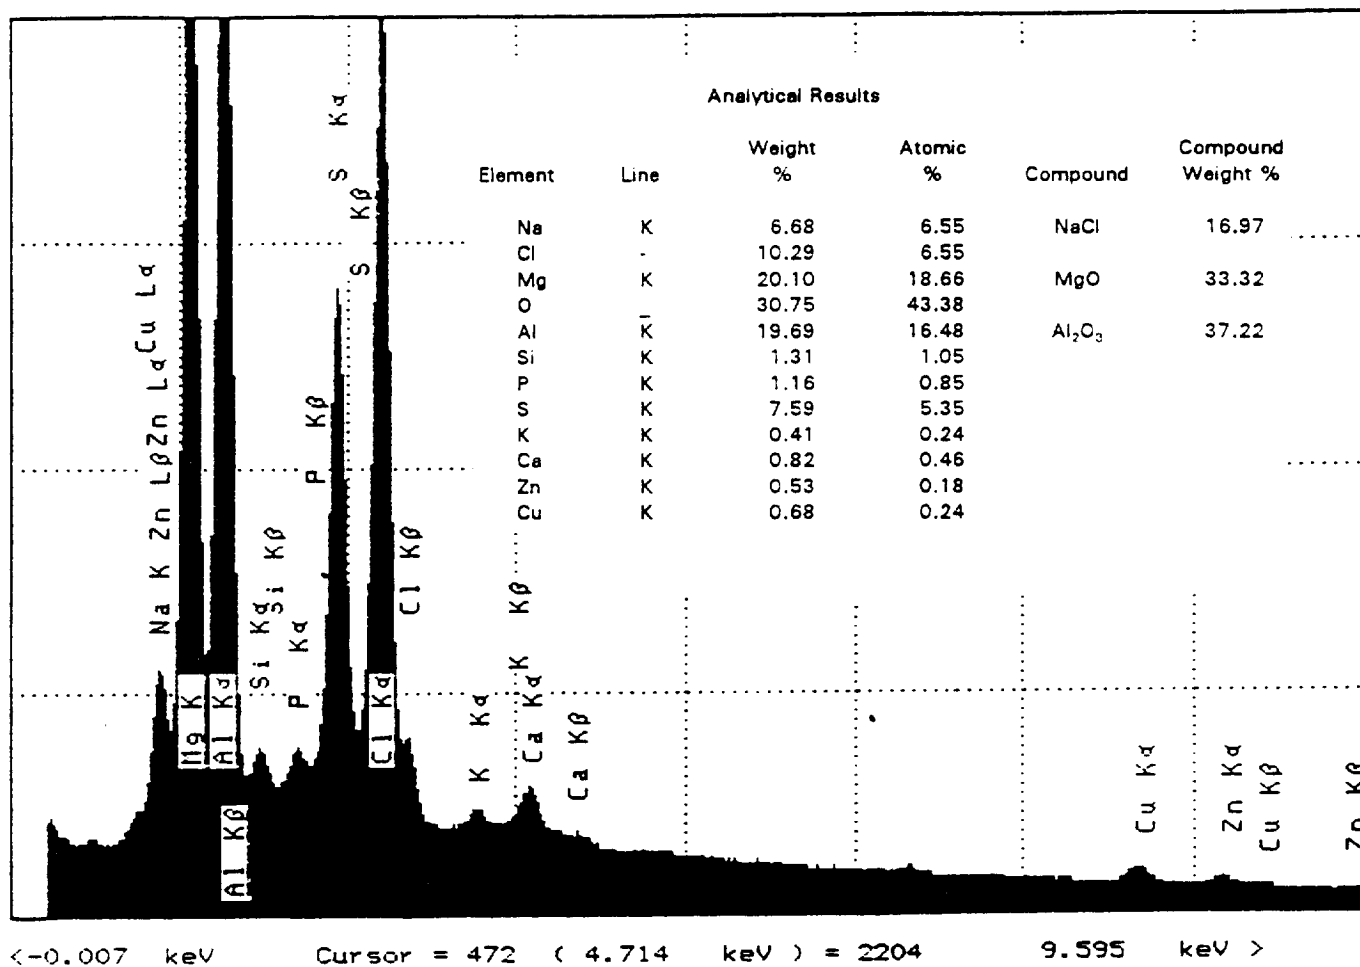
EDX analysis of regions on and off the second phase mounds is shown in Figures 39 and 40. Since our previous experience with Auger spectroscopy has shown that the growth features are Al_2O_3 , MgO, and NaCl, we have assumed these stoichiometries when calculating quantitative EDX compositions in order to determine the amount of each compound present (despite the fact that the EDX technique with our present X-ray window cannot O). In doing so, we assume that the EDX signal is originating entirely from the second phase mounds (a safe assumption here, since the mounds are very thick). The EDX results do not suffer from the effects of electron stimulated desorption (as seen previously in Auger analysis) because most of the EDX signal originates from under the surface).

Fig. 39. EDX spectrum atop the localized mound in Figure 38(a). See position 1 in Fig. 38(a). The second phase material is mostly Al₂O₃, MgO, and NaCl.

The EDX composition of the second phase mounds (position 1 in Fig. 39) shows that the large mounds are composed of (by weight %): $1/3$ Al_2O_3 , $1/3$ MgO , $1/6$ NaCl , and $1/6$ other elements. EDX analysis off to the side of one of the mounds (position 2 in Fig. 3) shows small amounts of Na, Mg, and Cl, indicating that growth of Al_2O_3 , MgO , and NaCl has occurred in a thin film that the incident electron beam has penetrated. Since the film is so thin in this location, most of the EDX signal at this position originates from the 2219 substrate and is mostly Al. That a thin film of Al_2O_3 , MgO , and NaCl exists on seawater-exposed specimens was shown in previous Auger work.

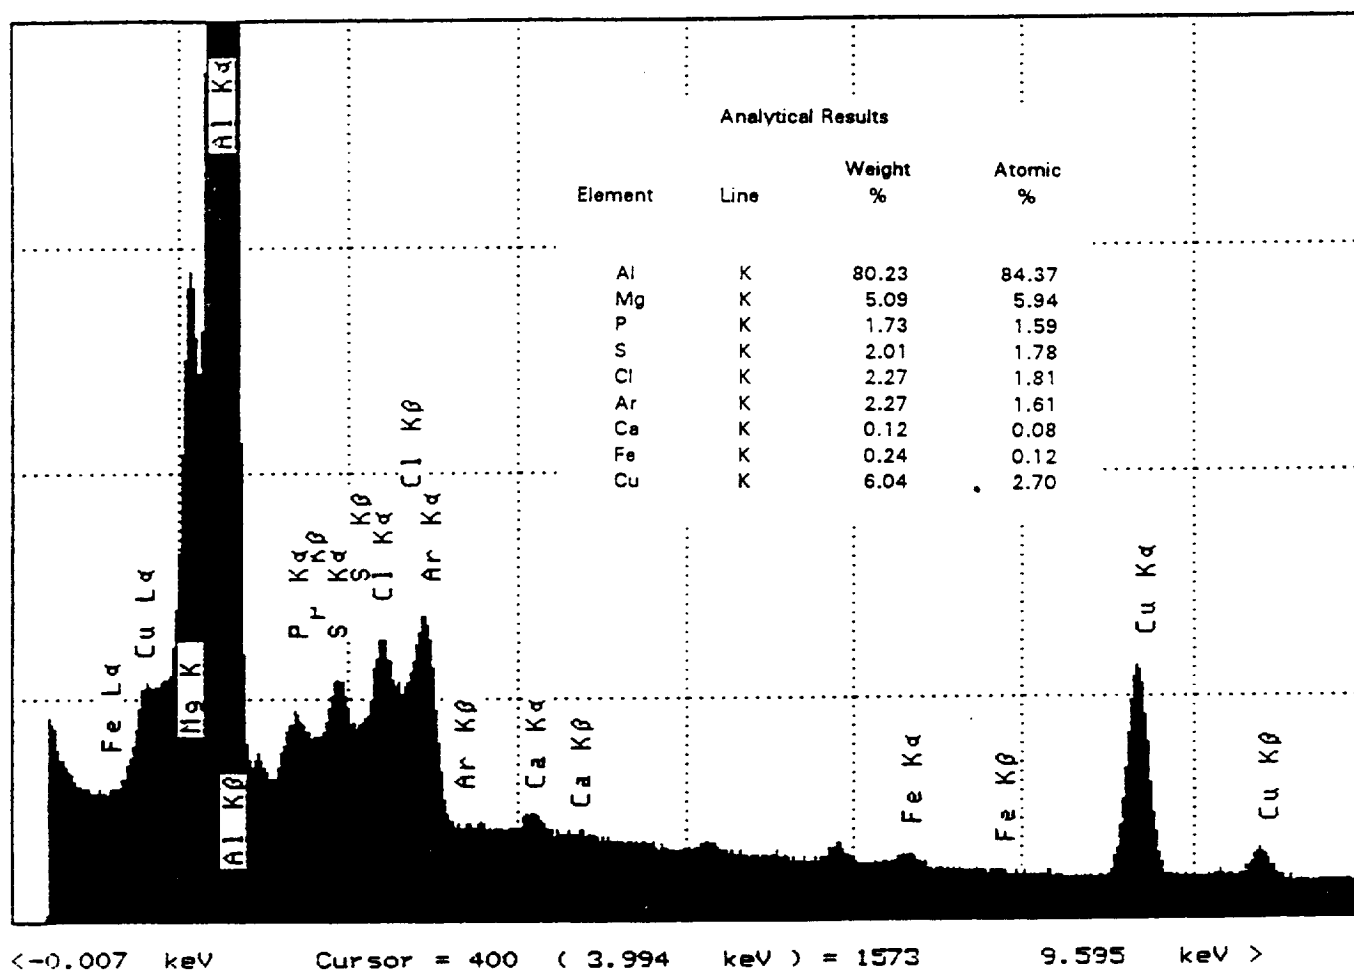
Fig. 40. EDX spectrum off to the side of the localized mound in Figure 38(a). See position 2 in Fig. 38(a). A thin film of precipitated Al_2O_3 , MgO , and NaCl is indicated, but the incident beam penetrates through it so most of the detected signal is from the underlying 2219 Al substrate.
